**Seismic Assessment of Historical  
Buildings in Palestine  
Nativity Church as a Case-Study**

**This Thesis is submitted in a Partial Fulfillment of the Requirements  
for the Degree of Master of Structural Engineering, Faculty of  
Graduate Studies, An-Najah National University, Nablus, Palestine.**

**2019**

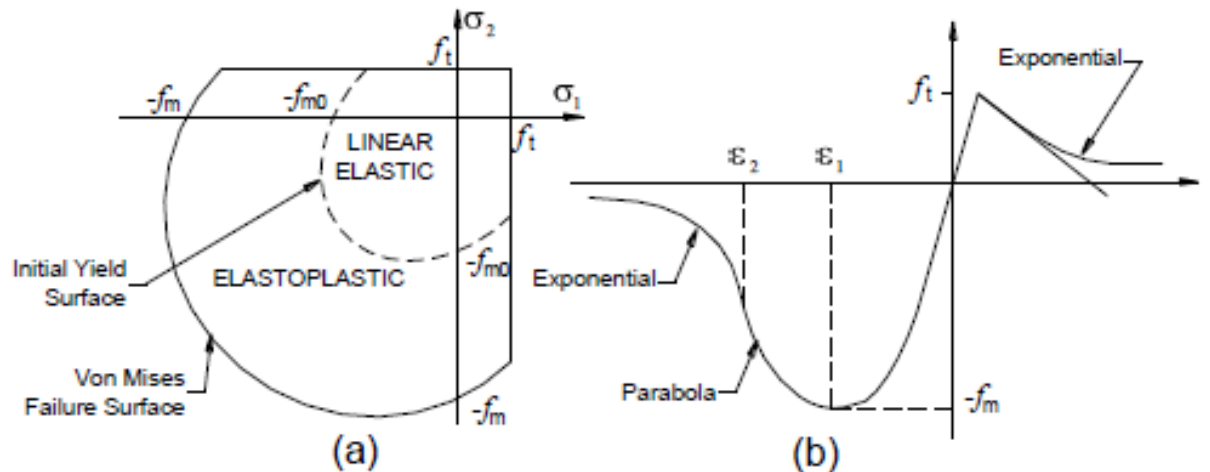
Masonry usually characterized by a quasi-brittle behavior, which refers to the way the force is transferred through the material. In details, after the peak load is reached the force gradually decreases to zero, which is called softening procedure, which is defined as the gradual decrease of resistance under a continuous increase in force caused deformation upon a material's structure. It is a notable feature of quasi-brittle materials like concrete, ceramics, clay brick, mortar, and rock, which fail due to a process of progressive internal crack growth. The phenomenon of softening has been well identified in parallel in tensile and shear failures of masonry, (Lawrence Livermore National Laboratory, 2009). Otherwise, in compression, softening behavior depends on the boundary conditions in the experiments and sizes of the specimen, figure (2.2) below, present the stress-strain relationship of unreinforced brick masonry and the yield criterion.

**Figure (2.2):** Yield Criterion and a Typical Stress-strain Model for Brick Unit.

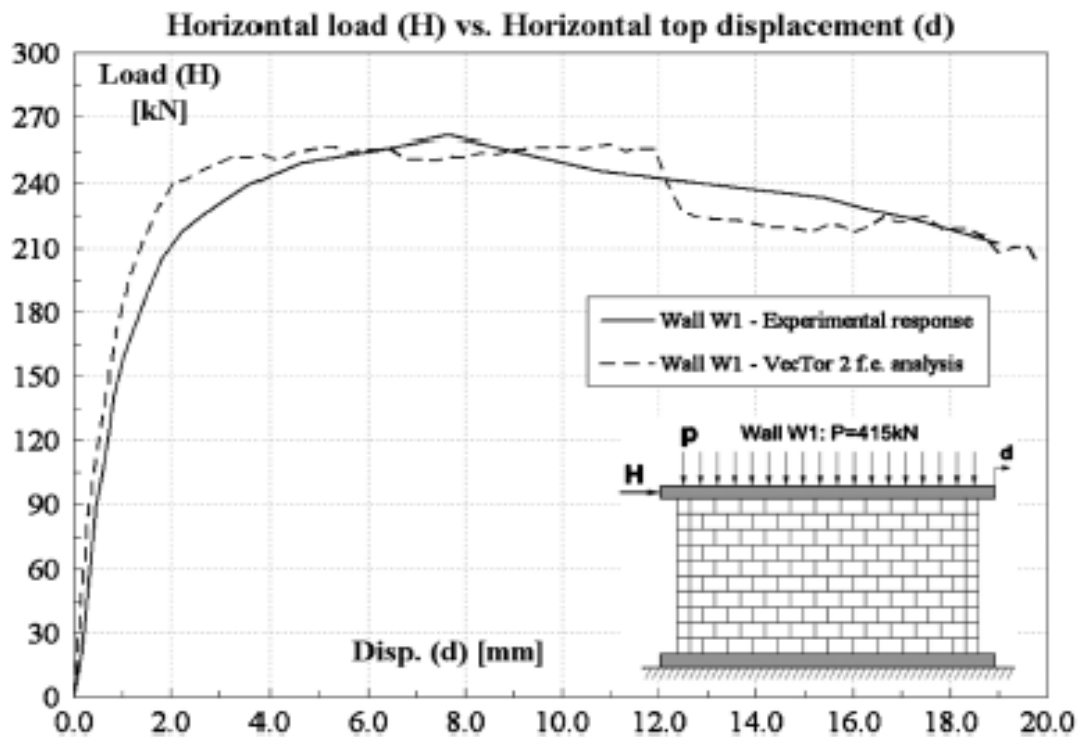
Different ways for the application of the load can be performed, for defining different types of pushover analysis. A monotonic pushover analysis considers a monotonic lateral load pattern which pushes the structure until the lateral capacity is reached; therefore the capacity of the structure is dependent mainly on the loading pattern.

**Figure (2.7):** Load Displacement Curve. [Facconi, Plizzari, & Vecchio, 2013]

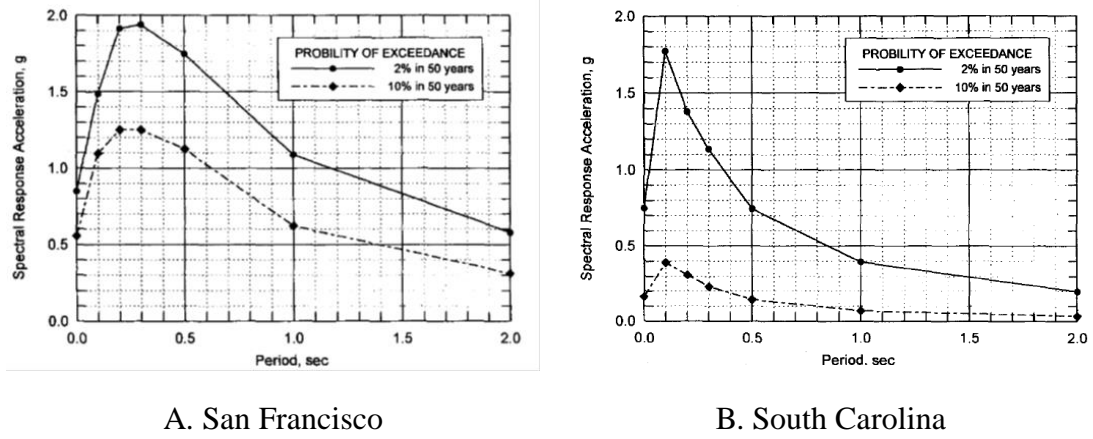
earthquake engineering, gives  $\tau$  of 2500 and 475 years, respectively, figure (2.10)

**Figure (2.10):** Hazard Response Spectra for 2% & 10 %, POE in 50 years.

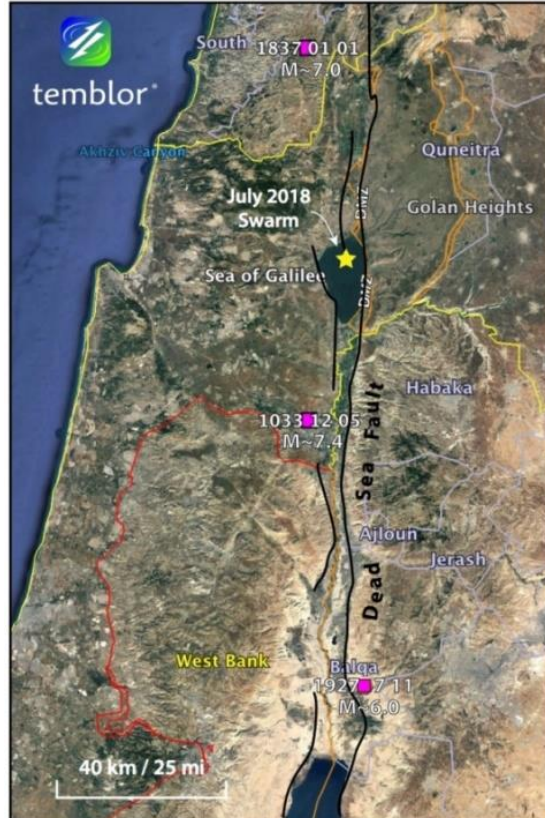
**Figure (2.11):** Dead Sea Fault, [Klinger, Avouac ,Dorbath, Abou Karaki, and Tisnerat , 2000]

However, other evidence, concerning the activity of secondary faults, besides the one in the Jordan Valley that may indicate a higher activity than previously thought. Palestine is located between the Arabian and African plates (Klinger, Avouac, Dorbath, Abou Karaki, and Tisnerat, 2000), as the figure (2.11) present.

The recent studies of crustal structure, shown the crust directly under the fault valley is somewhat different from that on the sides, so as a result, these differences in crustal structure may have controlled the evolution of physiography in the region (Ben-Avraham, Lazar, Schattner, Marco 2001). Moreover, the physiography of the Dead Sea fault is also affected by the vertical motion, which caused settlements of the floor of the rift and uplift of its shoulders. The Dead Sea fault characteristics can be arranged into into four main segments; S1: Ghab Valley segment, S2: Missyf Graben segment, S3: Lebanon Bend segment, and S4: Jordan & Araba Valley segment.

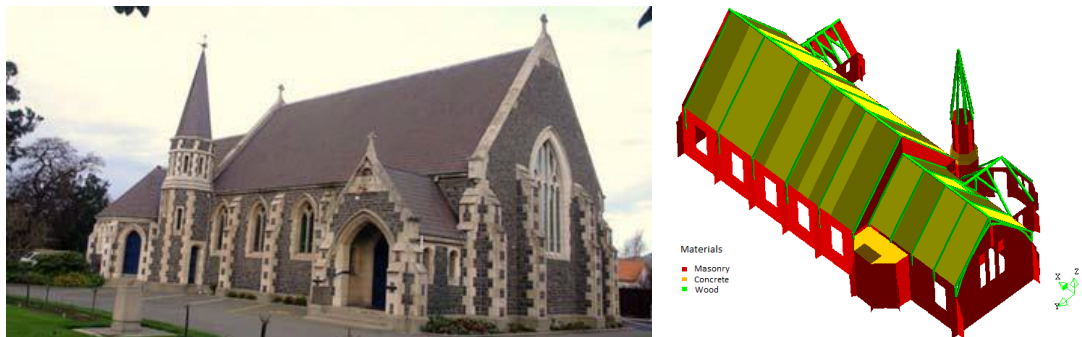
**Figure (2.13):** General View of St. James Church and the Numerical Model.

Over the years, and especially in last twenty years, researchers have studied the seismic assessment and performance of historical buildings, including their details, difficulties, mechanisms, regions, and rehabilitation process. One of the important studies was done by, Araújo, Lourenço, Oliveira and Leite, in 2012, for the St James Church, which was studied and assessed by means of pushover analysis (Before and After the New Zealand Earthquake), and presents a numerical study in details for the seismic assessment of the St James Church in Christchurch- South Island, The structural behavior of the Church has been evaluated using the finite element modeling technique, by using it; the nonlinear behavior of the structure has been taken into account by proper constitutive assumptions, figure (2.13).

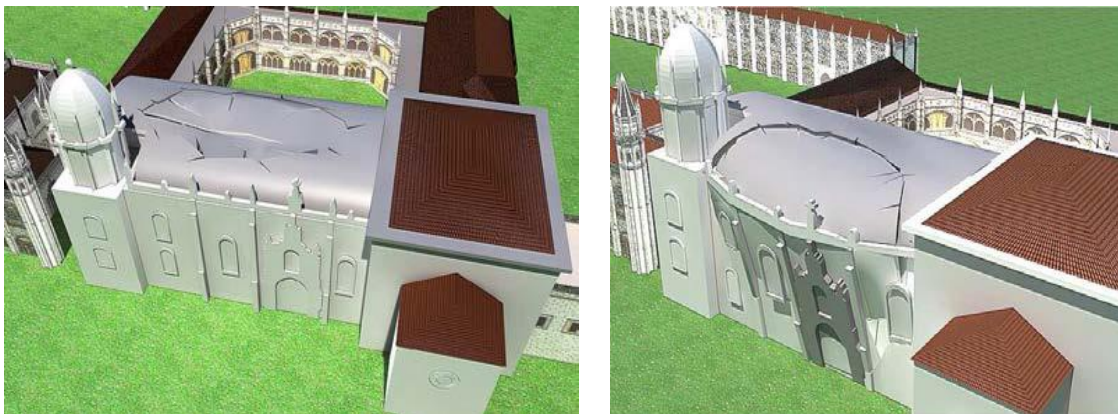
Paulo Lourenço, with cooperation with another team consisted of João Roque, and Daniel Oliveira, in the same year (2012), investigates the seismic safety of Monastery Church in Geronimo – Portugal. The work was done with a full data about the seismic behavior of the Church of Monastery of Geronimo, which is discussed with a numerical simulation, figure (2.14). Using artificial seismic acceleration time histories in agreement with three seismic hazard scenarios for 475, 975 and 5000 years return periods, allowing assessing its seismic safety. The detailed analysis for vertical loading and seismic loading results is indicating that the safety level of the structure is adequate for vertical and horizontal loadings. Also, the monitoring system installed allows the structural health of the church to be monitored, particularly in case of future earthquakes, providing excellent feedback for future analysis of damage.

**Figure (2.14):** Virtual Collapse Mechanisms. [P. Lourenço, J. Roque, D. Oliveira, 2012]

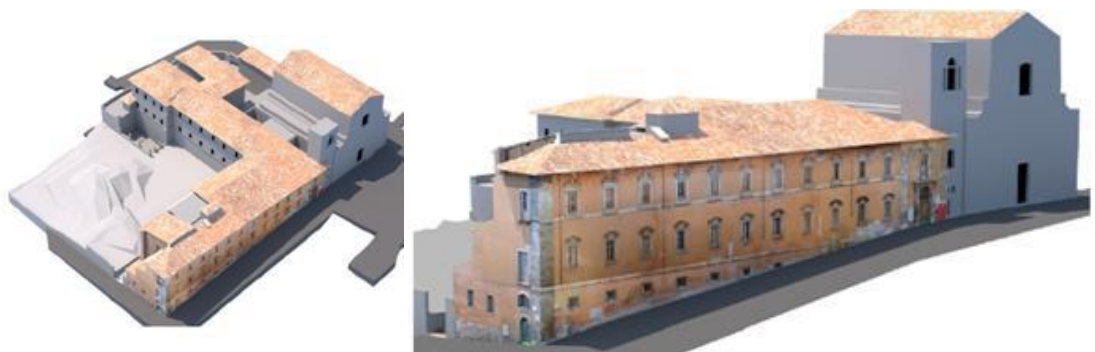
**Figure (2.15):** Camponeschi Palace - L'Aquila, Italy. [ F. Bucchi, S. Arangio and F. Bontempi , 2013]

In particular, its application with SAP2000 is presented; this approach is applied to a façade of an historical building that was damaged by the 2009 L'Aquila earthquake central Italy. The considered building is the Camponeschi Palace which is shown in figure (2.15), located in L'Aquila city center. The damage mechanisms obtained are compared with the observed damage and with those obtained from other approaches.

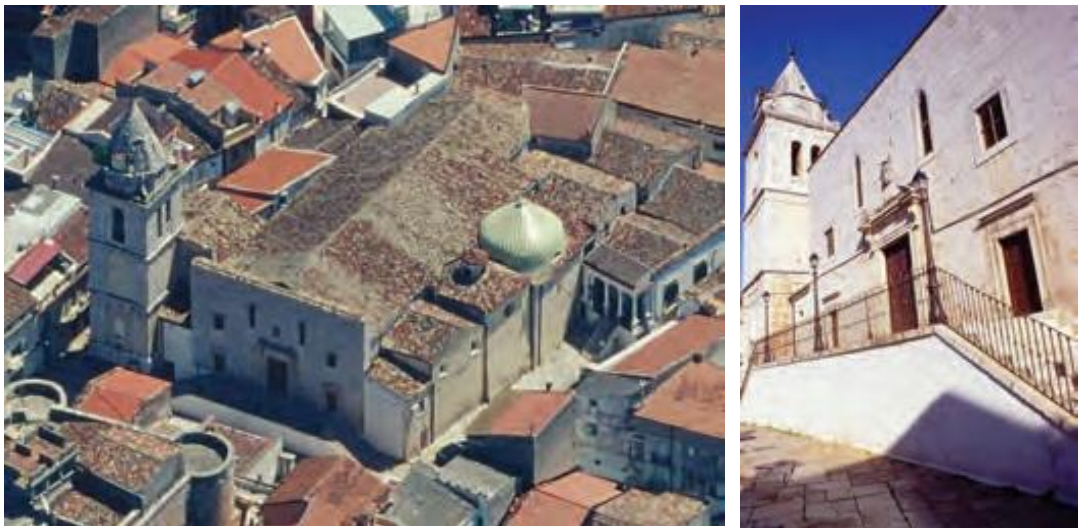
**Figure (2.16):** Photograph of Madre Santa Maria del Borgo Church, Italy. [G. Castellazzi, C. Gentilini, and L. Nobile , 2013]

In the same topic, G. Castellazzi, C. Gentilini, and L. Nobile, in 2013, study the seismic vulnerability of the Basilica of church which is located in Italy, by means of limit analysis and nonlinear finite element analysis, figure (2.16). The attention here is posed similarly to the failure mechanisms of the façade of the church and its interaction with the lateral

walls. For more details, the limit analysis and the nonlinear finite element analysis provide an estimate of the load collapse multiplier of the failure mechanisms.

Investigations based on results obtained from limit analysis and nonlinear finite element analysis have been conducted on some macro elements with special attention to those that interact with the façade, and the results obtained from both approaches are in agreement and can support the selection of possible rehabilitation process and scenarios in order to decrease the vulnerability under seismic loads.

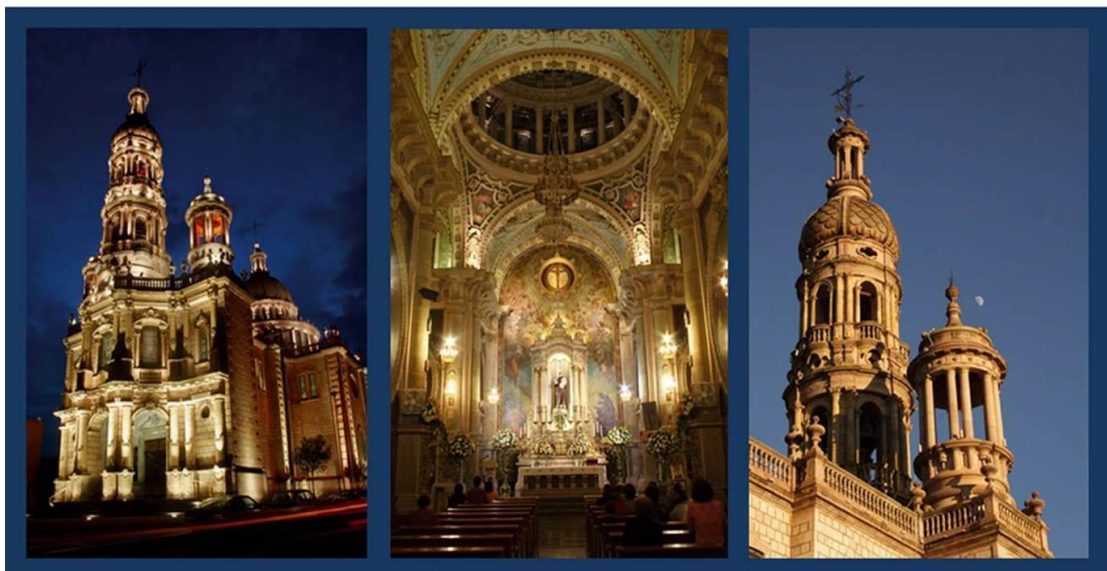
**Figure (2.19):** Views of The Temple of San Antonio, [H. Animas, M. Navarro, J. Pacheco

Another adapted methodology was followed by H. Animas, M. Navarro, J. Pacheco Martínez, J. L. García, T. Cordero, C. J. Esparza, and J. A. Ortiz-Lozano, in the year of 2014, with purpose of perform an structural analysis of the temple of San Antonio in Aguascalientes, México, figure (2.19) According to this work, three-dimensional analytical macro models are evaluated using the finite element method, the analysis was performed taking into account the linear and non-linear behavior of the masonry.

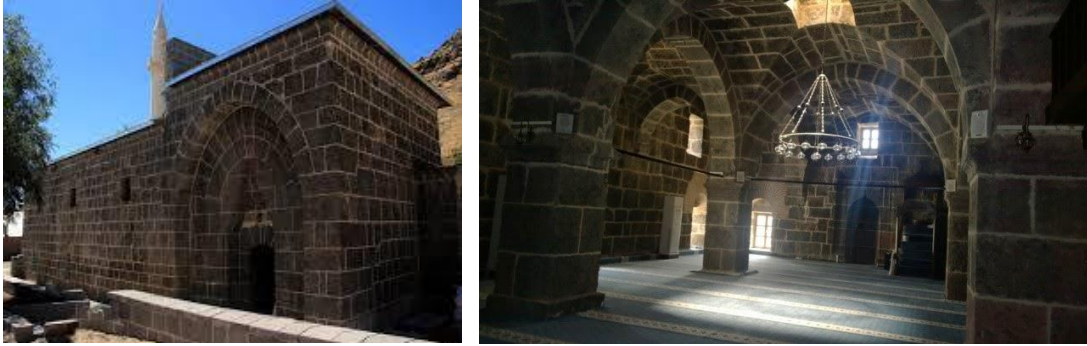
**Fig.(2.22):** Elti Hatun Mosque with its Outside and Inside View. [P. B. Lourenço with L. Mangia, B. Ghisaasi, E. Sayın, O. Onat, 2016]

For the Turkey historical moments, again P. B. Lourenço with L. Mangia, B. Ghisaasi, E. Sayın, O. Onat, show the pushover analysis of a historical masonry structure Elti Hatun Mosque, figure (2.22), which is located in Tunceli, Turkey. It is located in the seismic zone 2 according to seismic zone map of Turkey. The modeling and analyzing with Diana finite element software based on real dimensions measured by site visiting, and by adapting macro modeling strategy to model masonry elements.

The results show that the structure is two times weaker in the transversal direction than longitudinal direction, for the main reason referred to existence of the main gate of the structure which works as a rigid support system in the longitudinal direction. On the other hand, the vertical pushover analysis also was done in the same manner, to investigate the safety factor of the mosque under its self-weight, the results is acceptable in all directions. However, the presented results are only a prediction of the behavior due to several uncertainties about the material properties.

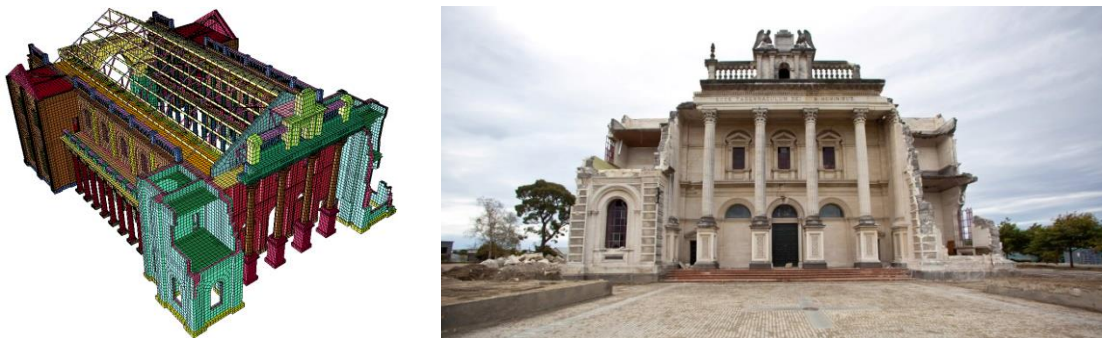
**Figure (2.23) :** General and 3D View of Cathedral of the Blessed Sacrament. [K. Ip, J.

K. Ip, J. Lester and A. Brown, in 2016, investigate the Cathedral of the Blessed Sacrament, Christchurch – New Zealand, and focusing on the seismic nonlinear analysis of these damaged historic buildings, because as they said, there is no existence for any established guidelines and the only methods of prediction of the structural behavior of historic buildings is empirical. Their used approach is to combine the advantages of the continuum method i.e. Finite elements, with the discrete method, by using constitutive models and contact surface algorithms, which are available in the numerical simulation software LS-DYNA, figure (2.23)

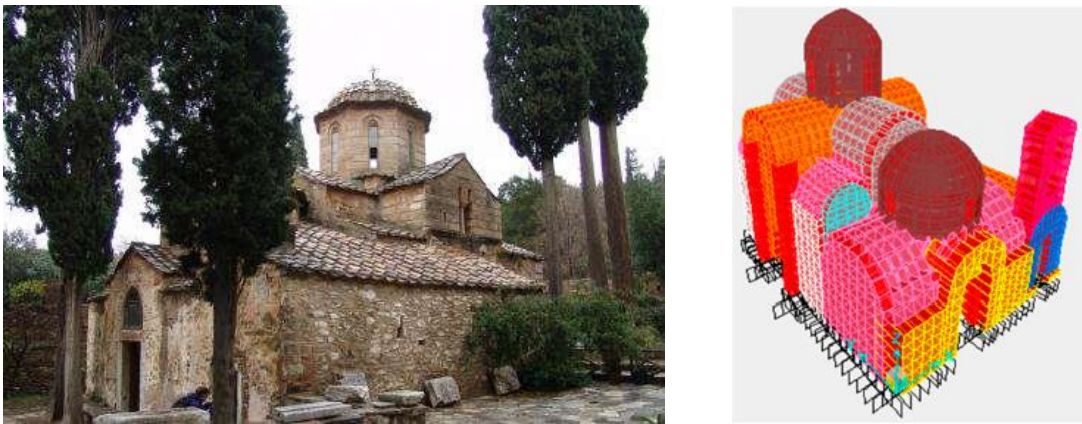
**Figure (2.24):** General and 3D view of Kaisariani Monastery in Athens, [Asteris ,  
Douvika, Apostolopoulou, and Moropoulou, 2017]

parameters, such as seismic characteristics, material strength, and utilizes fragility analysis based on different failure criteria. The application of the entire methodology is illustrated in the case of a historical and monumental masonry structure, namely the assessment of the seismic vulnerability of the Kaisariani Monastery in Athens, Greece, figure (2.24).

Based on the 3d analysis, the new stochastic computational framework for earthquake-resistant design of masonry structural systems has been established, namely, the fragility analysis has been applied based on the probabilistic behavior of crucial parameters involved in the modeling of the structure, such as the values of materials' strength and the peak ground acceleration. According to the analysis, it has been shown that the proposed approach offers a ranking method that supports civil authorities in optimizing decisions for choosing, among a plethora of structures, which ones present the highest levels of vulnerability and are in need of immediate strengthening. It also plays an important role for the

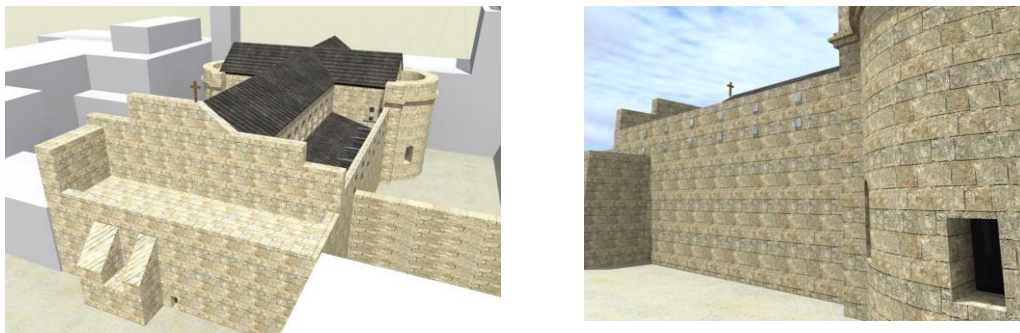
**Figure (2.29):** Aerial View of the South Wall. [Claudio Alessandri, Jessica Turrionim, 2017]

In another side, Claudio Alessandri, with cooperation with Jessica Turrionim in 2017, propose an innovative technique for reinforcing the wall of the Church of the Nativity against earthquakes. Local seismicity data and the parameters of an equivalent Italian site provided the input data for a design earthquake, and 3D modal analysis of the entire Church revealed that the structure is characterized by clear local modes of vibration. As per the most recent studies on masonry structures, local assessment based on limit analysis procedures was performed. This showed that in the event of an earthquake, a Crusade era wall addition is at risk of collapse via simple overturning around its own base, due to the lack of firm connections with the orthogonal walls of the façade and the transept. Hence, a novel double system of horizontal steel tension structures was designed to consolidate the wall, conforming to the main restoration Charter requirements, i.e. lightness, non-invasiveness and reversibility, and being hidden from the sight of visitors. In the absence of reliable local regulations, all analyses, computations and checks on the proposed intervention were carried out with reference to the Italian technical regulations.

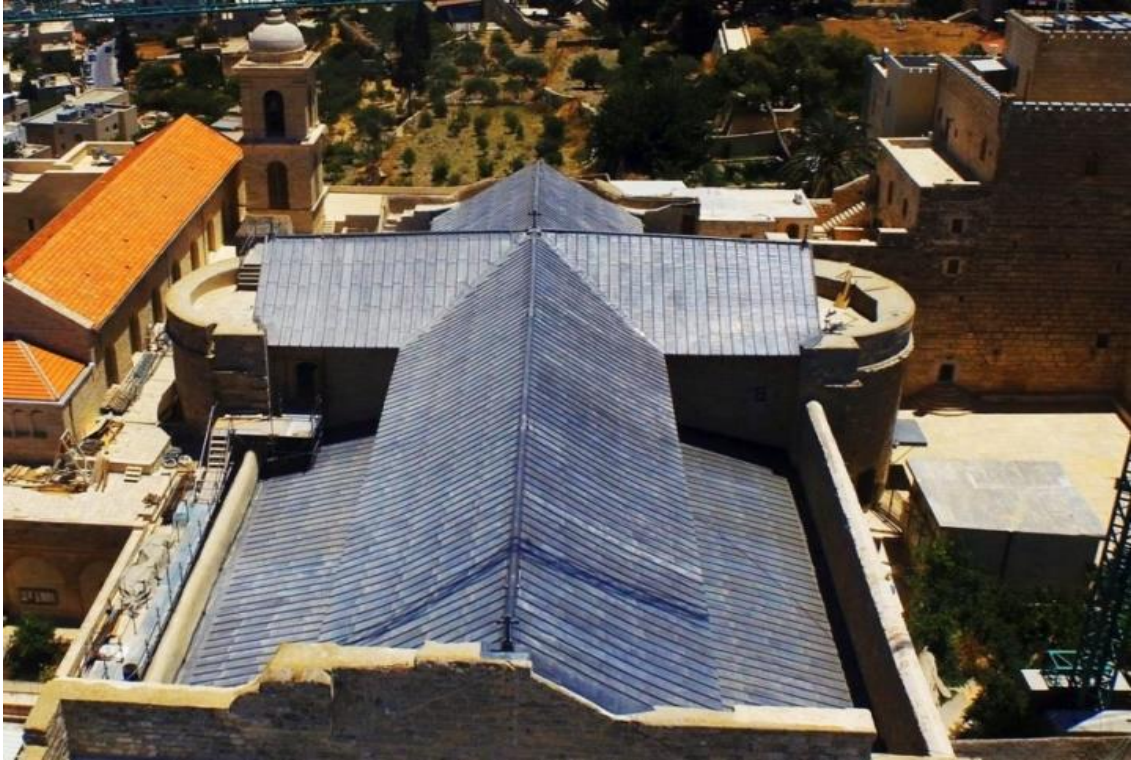
**Figure (3.1):** Perspective Picture for Church of the Nativity

This Church is one of the earliest Christian structures, which is the birth place of Jesus. The original Basilica, created in the 4th century by Emperor Constantine, which was completely damaged in the Samaritan Revolt, (Qustandi Shomali (2015)). It was replaced later on the same site, by another Basilica; it was different in its plan and had at that time, modified parts of the original building, figure (3.1) present this basilica.

The church mainly constructed of masonry walls, which are composite material consisting of an assemblage of stones and mortar joints, each of them has different properties, and due to the low tensile and shear bond strength, mortar joints act as a plane of weakness.

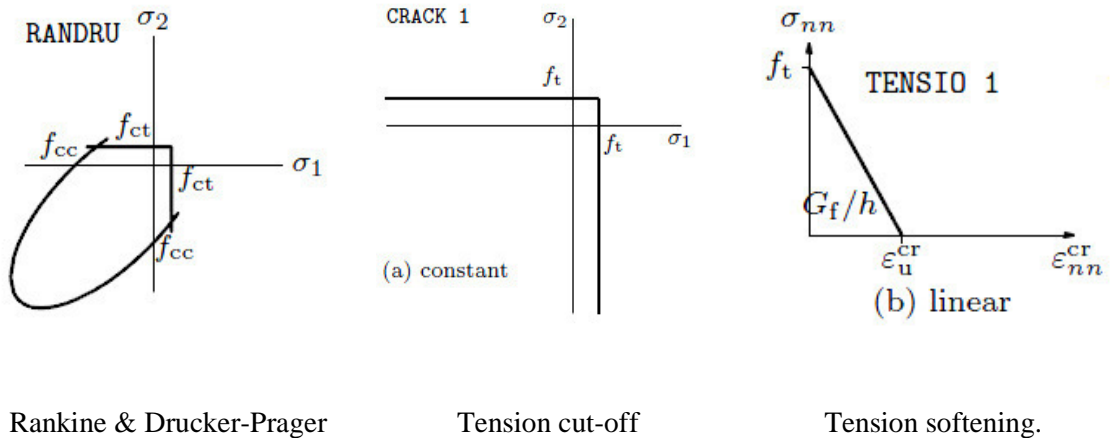
(4.1). In details, the Smeared cracking is specified as a combination of shear retention, tension softening and tension cutoff, with constant stress cut off is chosen. The linear tension softening based on the energy of fracture was selected, and used the crack bandwidth, where the cracks are not described one by one but are continuously spread within the element and reduce the stiffness, and finally, constant shear retention is chosen due to the cracking of the material, results of shear stiffness to be usually reduced.

**Figure (4.1):** Material Models Used for The Behavior of Masonry.
