**SEISMIC RAPID ASSESSMENT AND  
STRUCTURAL RETROFITTING STRATEGIES:  
CASE STUDY OF ESSENTIAL BUILDINGS IN  
TULKARM CITY**

**This Thesis is Submitted in Partial Fulfillment of the Requirements for the Degree of  
Master of Disaster Risk Management, Faculty of Graduate Studies, An-Najah National  
University, Nablus - Palestine.**

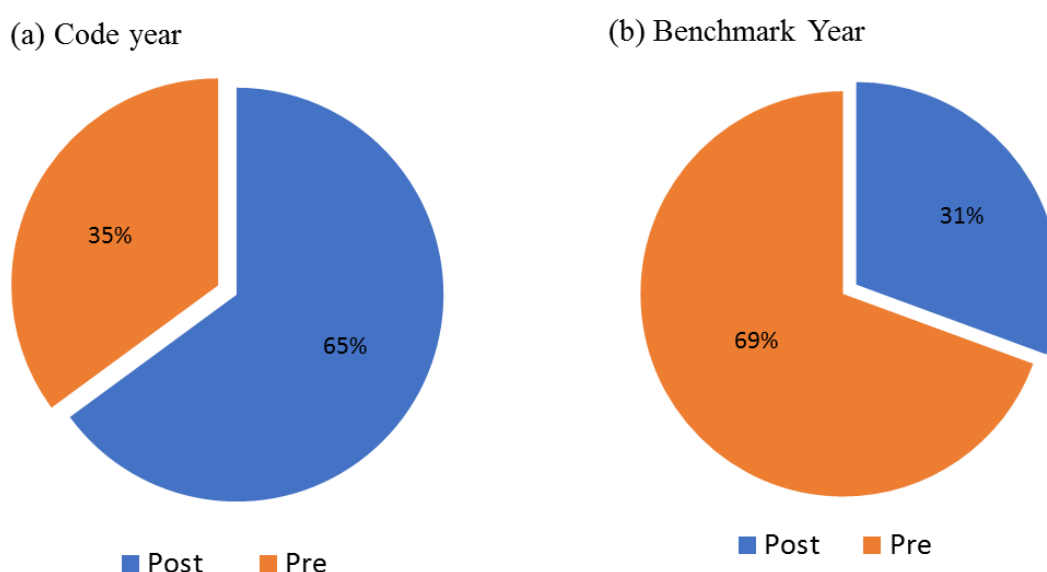
**Figure 8**

Since most of the screened buildings exist before seismic codes were included in the design, they were either constructed in a traditional, non-engineering manner (very old buildings) or only under the effect of gravity loads.

*Distribution of Buildings according to (a) Code year, (b) Benchmark year considerations*

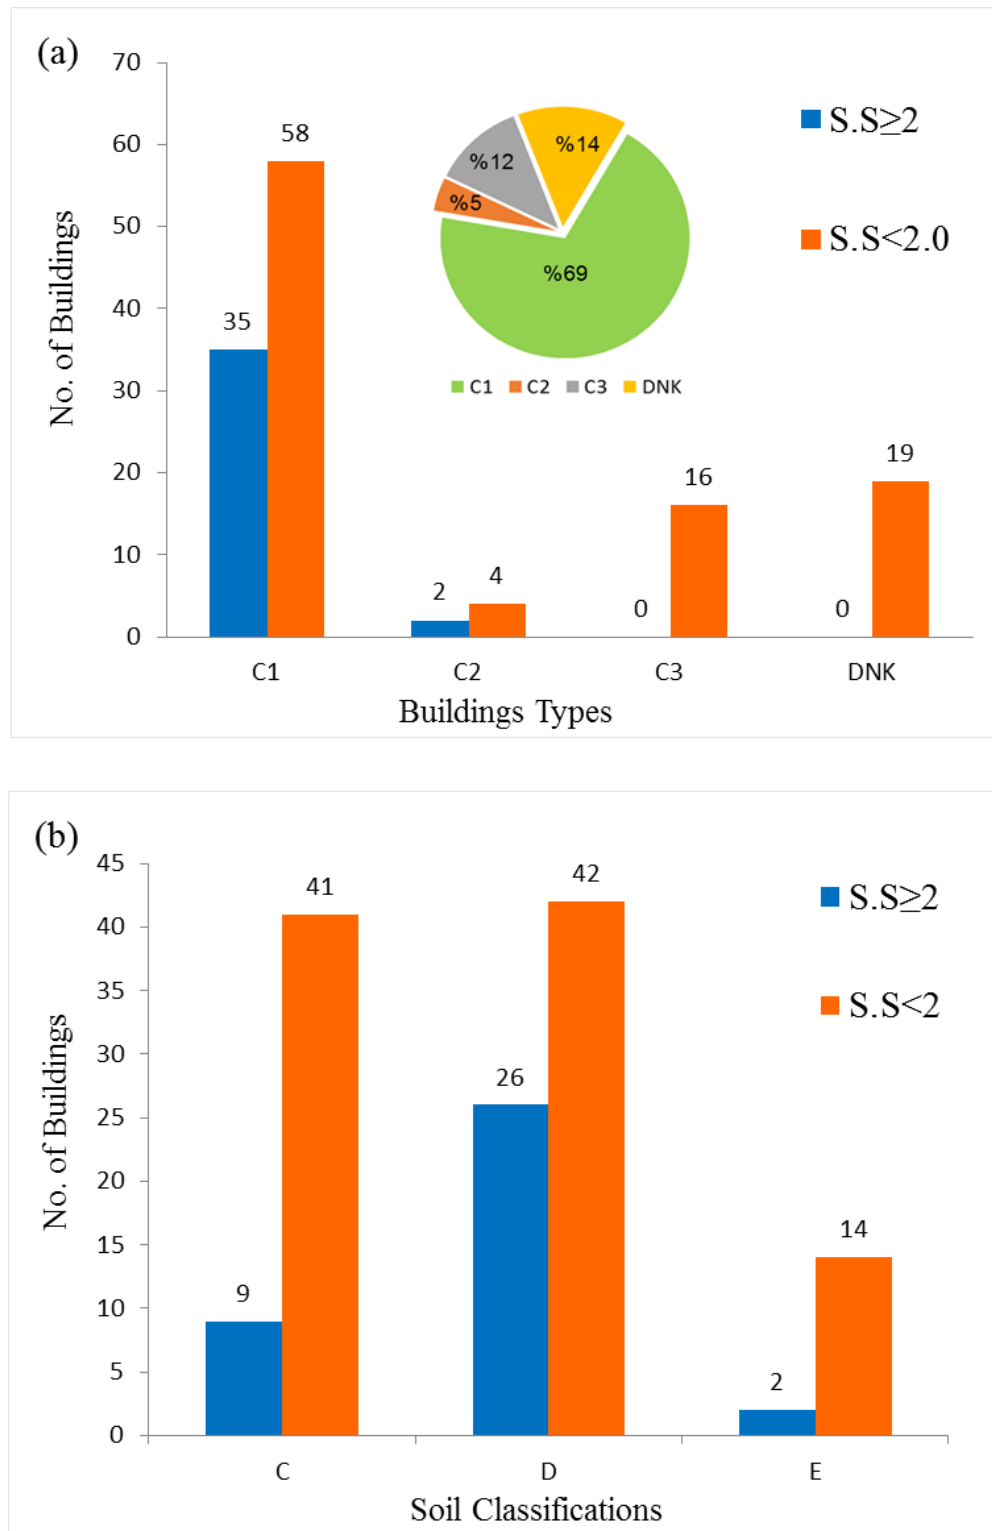
**Figure 9**

*The Effect of (a) Soil Classification, (b) Type of Buildings on S.S Values*

\* N: Number of stories, S.S: Structural Score.

The average height of the buildings is 3 stories, with buildings ranging from one to seven stories in height, as shown in Figure D.1. This parameter only affected the vulnerability assessment results for buildings located on Type E soil. In Figure 9(a), the RVS values were linked with the soil type for the buildings.

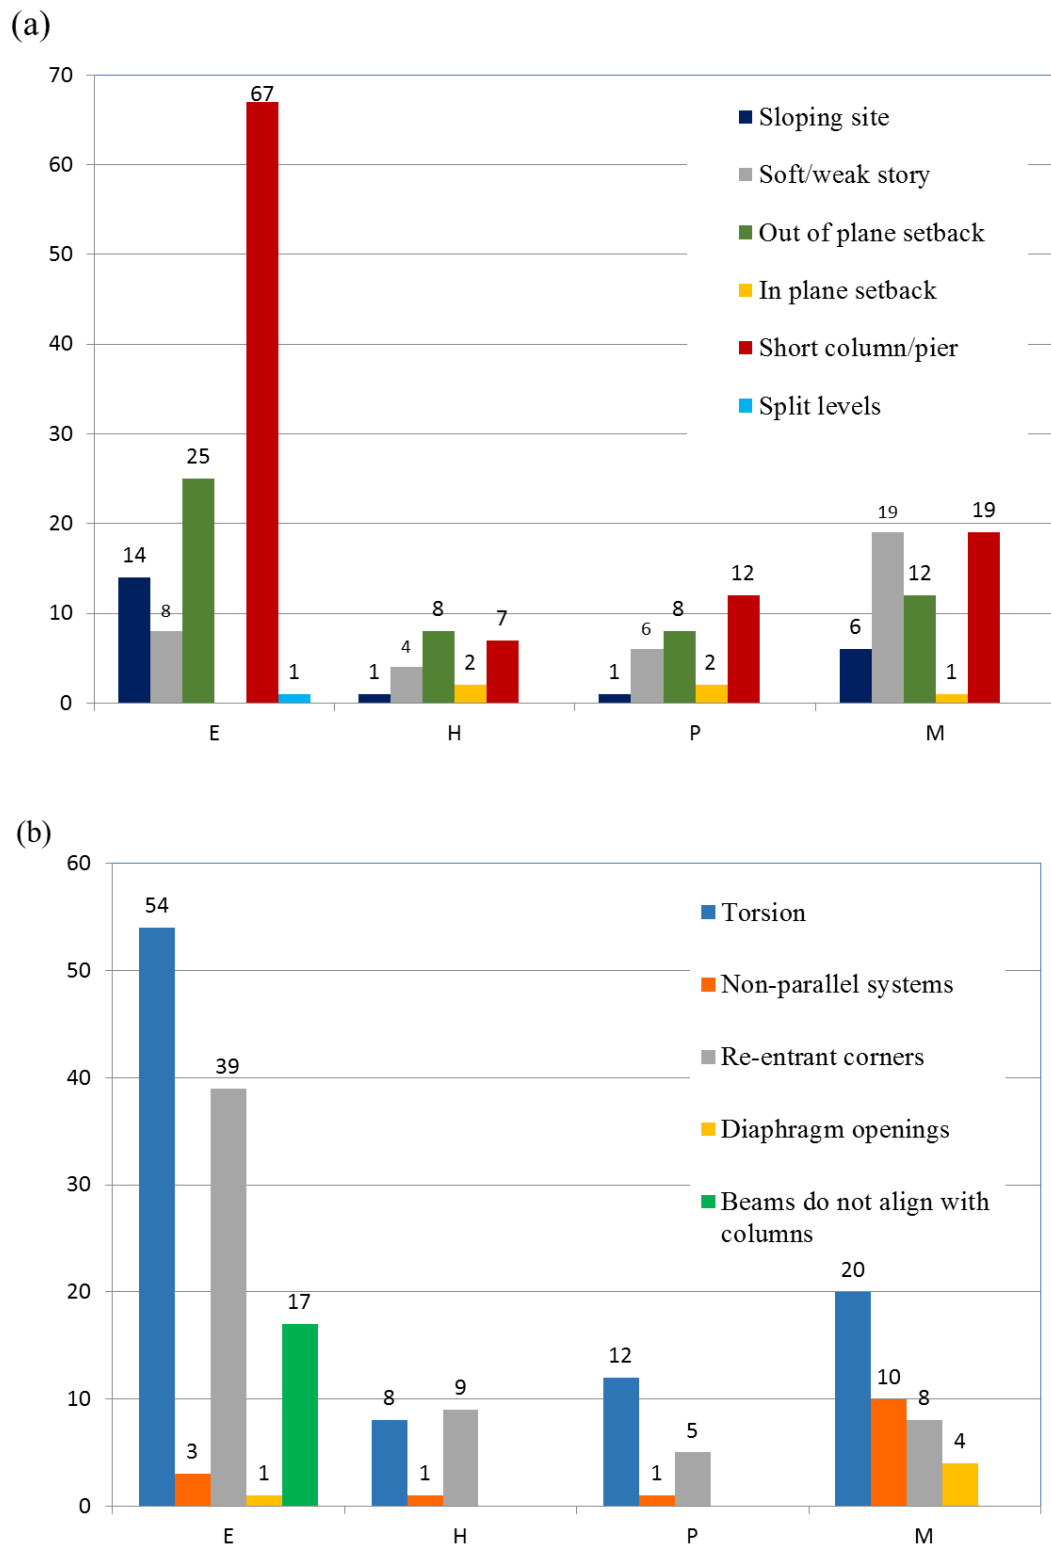
**Figure 10**

(a) Vertical Irregularity (b) Plan Irregularity Distribution according to Building use

Sever structural irregularities were identified during the investigation. However, as already shown in Figure D.5, vertical asymmetry, which is one of the most complicated cases, is more common among the buildings than plan irregularity, as about 96% of the buildings had different types of vertical irregularities. The same is true for plan irregularities: 81% of the buildings had one or more of these defects.

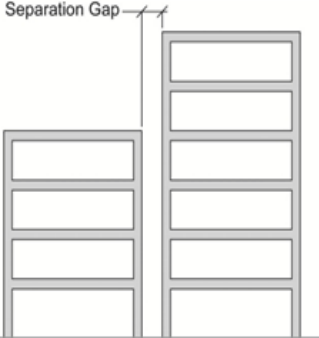
<p>Consider pounding when the separation between adjacent buildings is less than:</p> <ul style="list-style-type: none"> <li>• 2" times number of stories in shorter building (in Very High seismicity region)</li> <li>• 1 1/2" times number of stories in shorter building (in High seismicity region)</li> <li>• 1" times number of stories in shorter building (in Moderately High seismicity region)</li> <li>• 1/2" times number of stories in shorter building (in Moderate and Low seismicity regions)</li> </ul>

<p>Examples:</p> <p>a) Two 2-story buildings next to each other in High seismicity region: Minimum Separation = <math>1\frac{1}{2}" \times 2 = 3"</math></p> <p>b) 6-story building next to a 4-story building in Moderate seismicity region: Minimum Separation = <math>\frac{1}{2}" \times 4 = 2"</math></p>
<p>AND one or more of the following conditions apply:</p>
